U.S. Department
of Transportation
**Federal Aviation
Administration**

ADVISORY CIRCULAR 43-16A

AVIATION MAINTENANCE ALERTS

ALERT
NUMBER
305

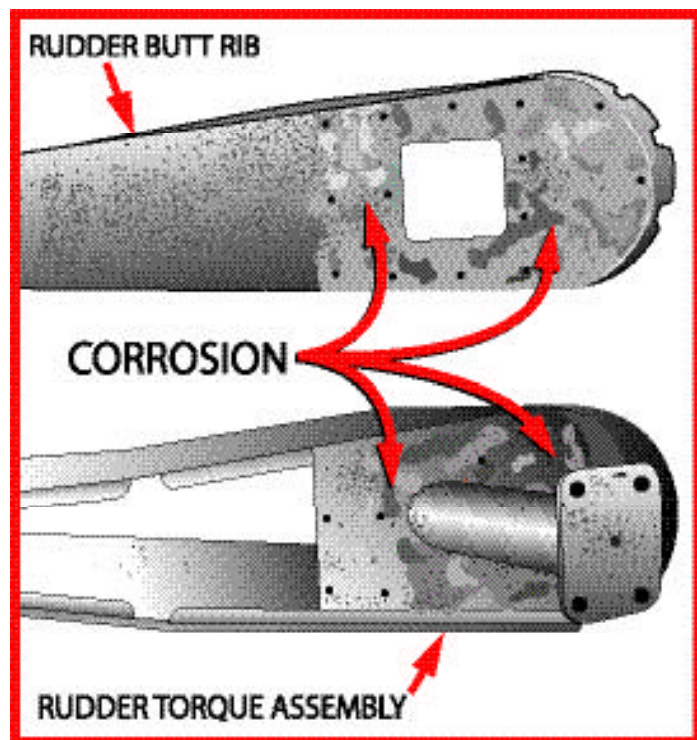
Piper; Model PA-31-325; Corroded Rudder and Rudder Torque Tube; ATA 2720

While complying with Service Bulletin 1105 (rudder torque tube inspection), severe rust and corrosion were found on the rudder butt main rib, rudder torque tube, and welded rib assemblies (P/N 40040-09). (Refer to the illustration.)

A search of the FAA Service Difficulty Reporting Program data base revealed seven additional reports citing corrosion of the rudder torque tube.

Part total time-2,687 hours.

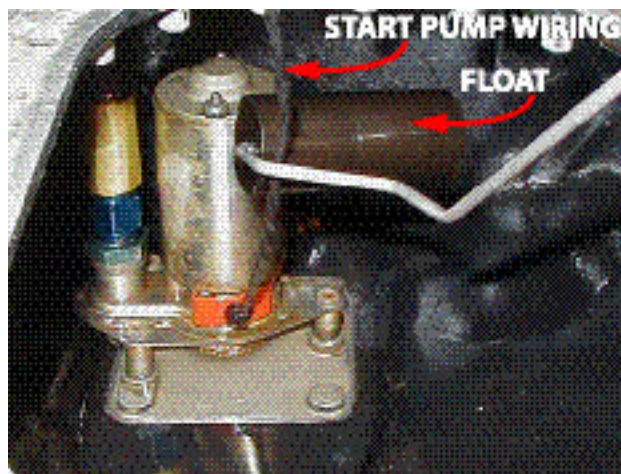
The fuel sending unit had been replaced in the helicopter's fuel tank and about one hour later the engine flamed out during a logging run due to fuel exhaustion. The pilot reported 110-120 pounds of fuel according to the fuel gauge and the "Low Fuel" Caution light never illuminated.

Examination determined that the fuel sending unit (float arm) had become entangled in the electrical power line that feeds the nearby start pump thus preventing the float from descending below the 120 pound level of fuel quantity (the Low Fuel sensor switch had been set at 60 pounds).

A mandatory service bulletin had been issued (15 September 1987) which discussed the procedure for ensuring that the start pump electrical wiring was properly secured to prevent entanglement with the fuel sending unit. The information in the SB was later incorporated in the maintenance manual but referenced only with respect to removal/replacement of the start pump itself. No such guidance was available in the maintenance manual for cases whereby the fuel sending unit (float arm) alone was removed/replaced as in the above-described case.

Examination for the security of the start pump wiring (i.e., either ty-wrapped or wound around the start pump fuel line) during any repair/replacement/removal of the fuel sending unit would likely prevent reoccurrence.
